CUMBERLAND GAP TUNNEL PAVEMENT PROBLEMS

1. Report No. KTC 05-35-KH50-05-1F		2. Government Accession No.		3. Recipient's Catalog No.																																																	
4. Title and Subtitle Cumberland Gap Tunnel Pavement Problem				5. Report Date October 2005																																																	
				6. Performing Organization Code																																																	
				8. Performing Organization Report No. KTC 05-35-KH50-05-1F																																																	
7. Authors Brad Rister				10. Work Unit No. (TRIAS)																																																	
9. Performing Organization Name and Address University of Kentucky College of Engineering Kentucky Transportation Center 176 Oliver Raymond Building Lexington, KY 40506-0281				11. Contract or Grant No. KTC 05-35-KH50-05-1F																																																	
12. Sponsoring Agency Name and Address Kentucky Transportation Cabinet 200 Mero Street Frankfort, KY 40622				13. Type of Report and Period Covered Final																																																	
				14. Sponsoring Agency Code																																																	
15. Supplementary Notes

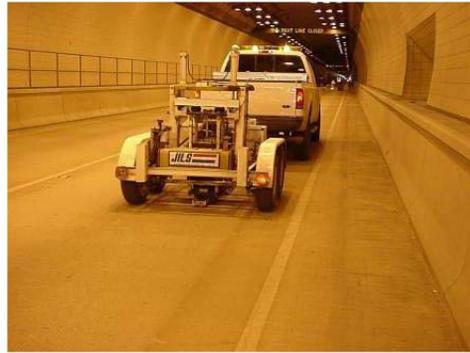
- 2001 (CGTA) requested a pavement inspection due to possible slab settlement
 - FWD testing CP 5 and 8 ½
 - Drainage inspection of tunnel drains

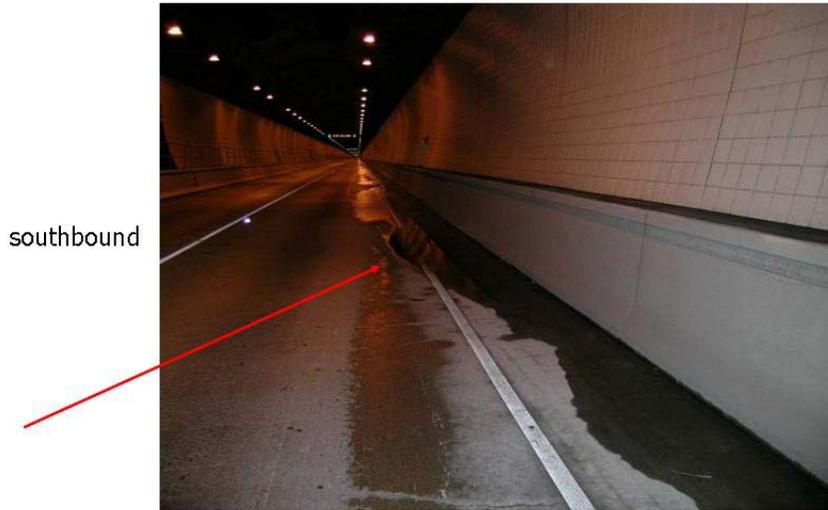
Visual of pavement settlement at CP 3 (water ponding after tunnel washing)

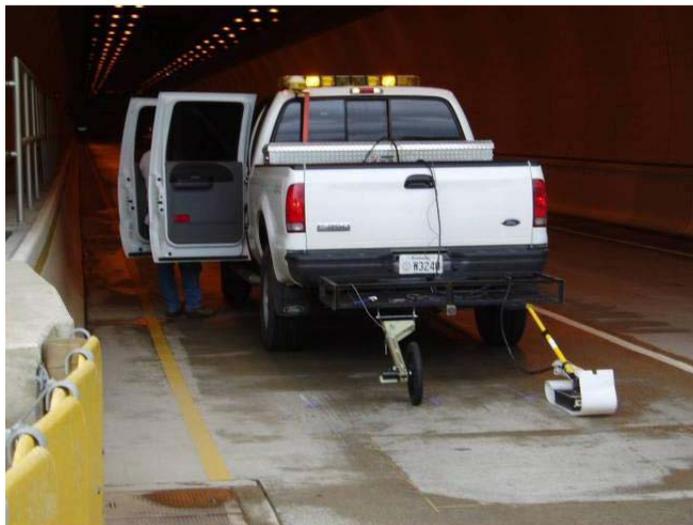
Ground penetrating radar inspection and results

Equipment
900 MHz. antenna
Approx. depth 3 ft.

Data collection location
3 passes per lane
CWP, RWP
LWP

Data collection density
1 scan every inch

Data collection speed
5 m.p.h.

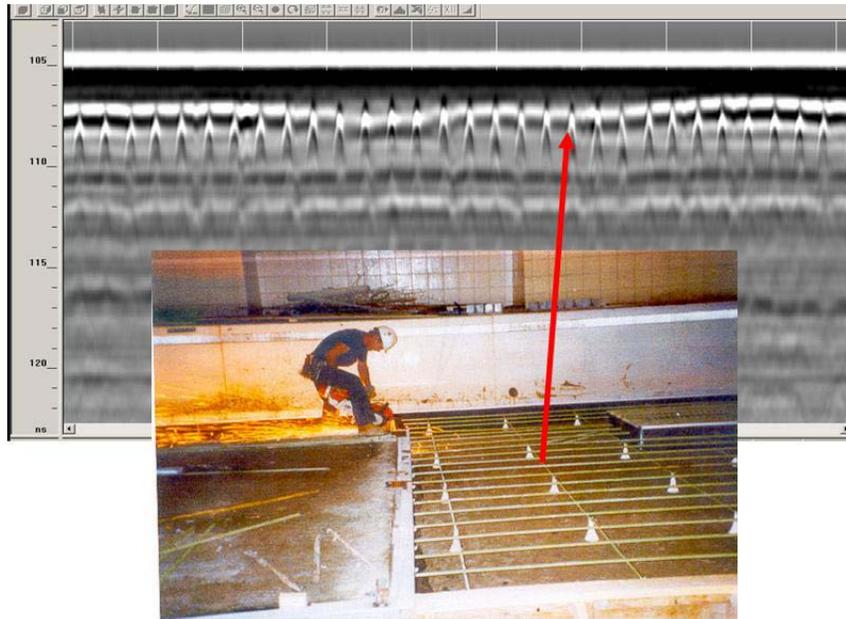
Good GPR data showing re-bar

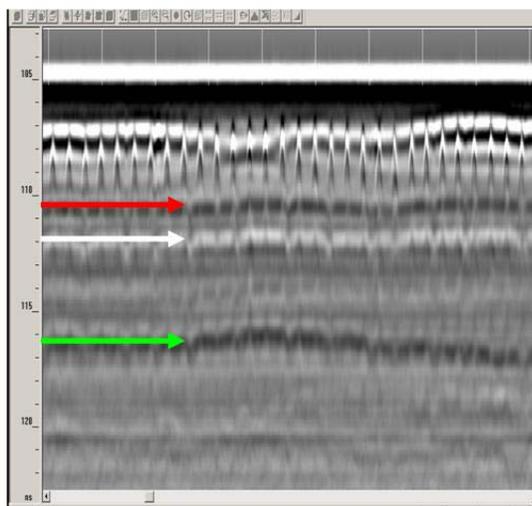
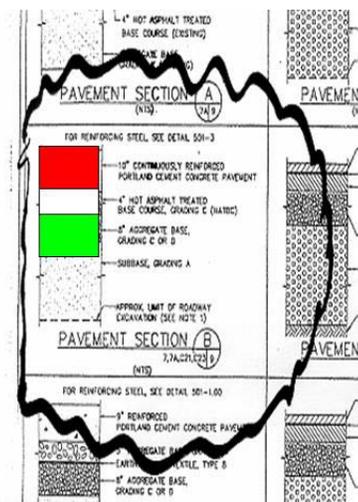
Good GPR data showing pavement layers

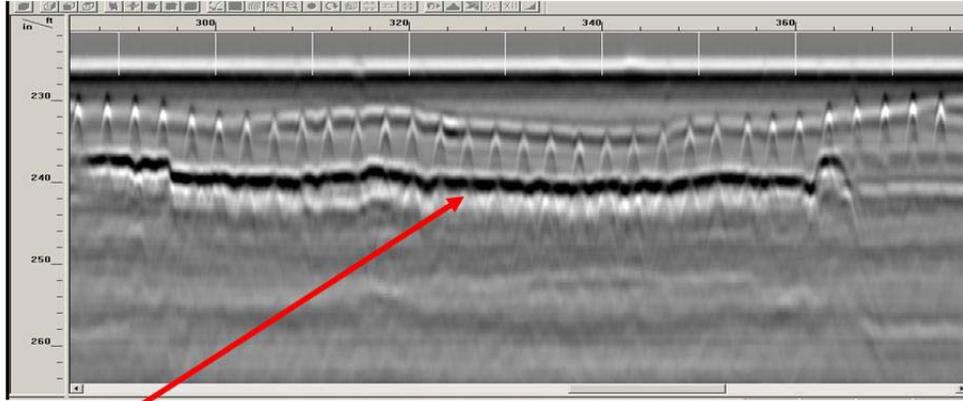
Void area beneath concrete pavement southbound tunnel

GPR signal has negative amplitude (noted as black space) because it doesn't have anything to bounce off of (namely air).

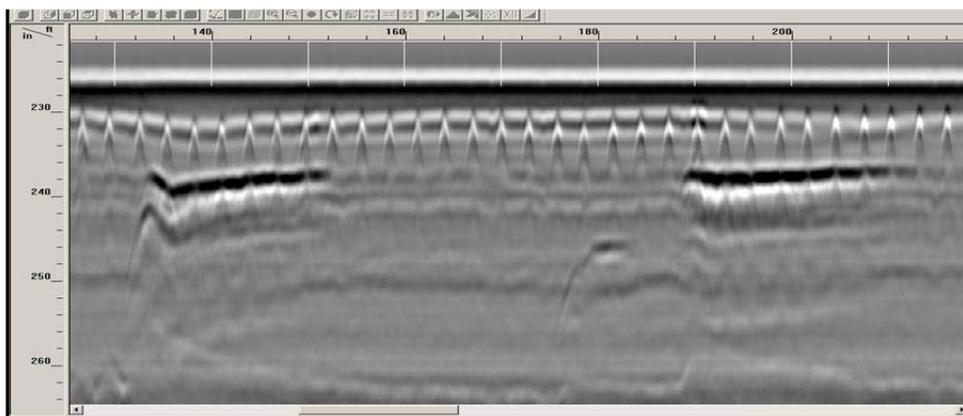
Multiple void areas beneath concrete pavement northbound tunnel

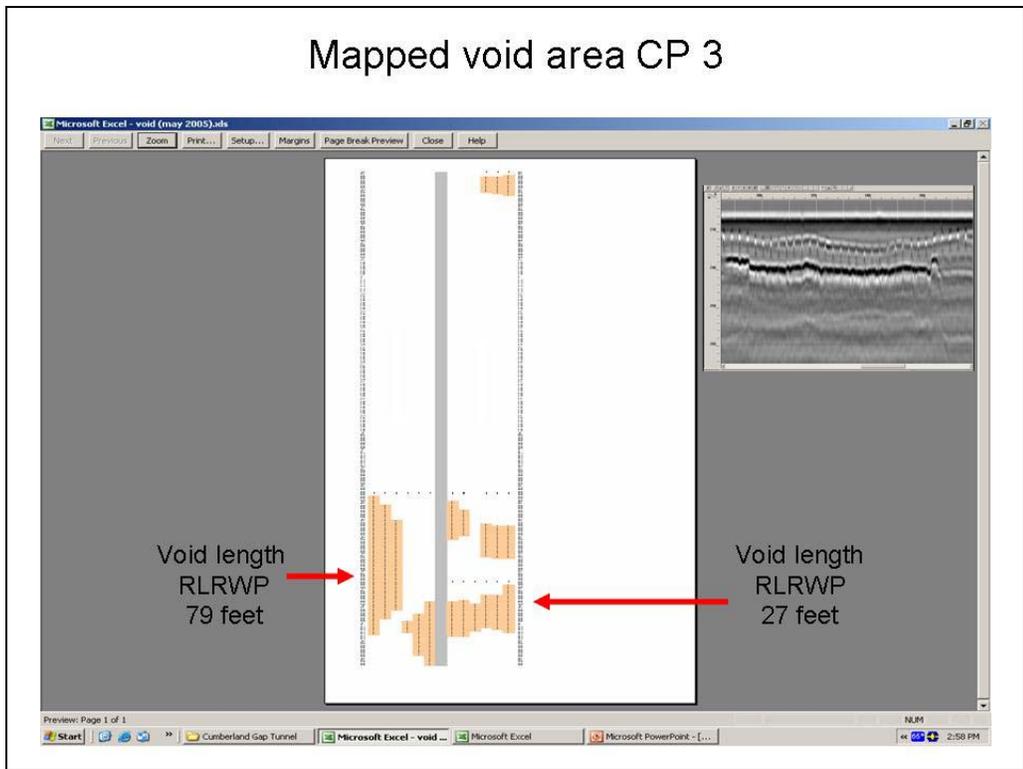
Mapped void area CP 3

Southbound void length CP 3

<u>location</u>	<u>lane</u>	<u>distance from left barrier wall</u>	<u>beg. Station #</u>	<u>end. Station #</u>	<u>Void Length (feet)</u>
lwp	left	4.6	122.98	123.34	35
cwp	left	7	123.05	123.28	23
rwp	left	9	123.09	123.15	6
lwp	right	17.6	122.51	123.02	51
cwp	right	20	122.42	123.07	65
rwp	right	22.3	122.37	123.16	79

Northbound void length CP 3

<u>location</u>	<u>lane</u>	<u>distance from left barrier wall</u>	<u>beg. Station #</u>	<u>end. Station #</u>	<u>Void Length (feet)</u>
lwp	left	4.6	123.17	122.98	19
lwp	left	4.6	122.61	122.40	21
cwp	left	7	123.17	122.97	20
cwp	left	7	122.59	122.45	14
rwp	left	9	123.14	122.99	15
lwp	right	17.6	123.12	122.94	18
lwp	right	17.6	122.71	122.53	18
lwp	right	17.6	120.61	120.53	8
cwp	right	20	123.13	122.94	20
cwp	right	20	122.72	122.54	18
cwp	right	20	120.62	120.53	9
rwp	right	22.3	123.15	122.88	27
rwp	right	22.3	122.72	122.54	18
rwp	right	22.3	120.63	120.52	12

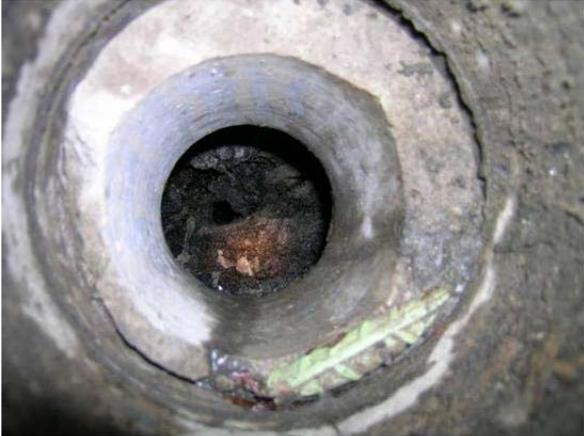
Void depth beneath 10 inch concrete pavement CP 3

Southbound

Sta. #	Lane	Void depth inch
122+77	R cwp	8
122+80	R cwp	7 5/8
123+00	L cwp	5 7/8

Northbound

Sta. #	Lane	Void depth inch
122+72	L cwp	2 1/4

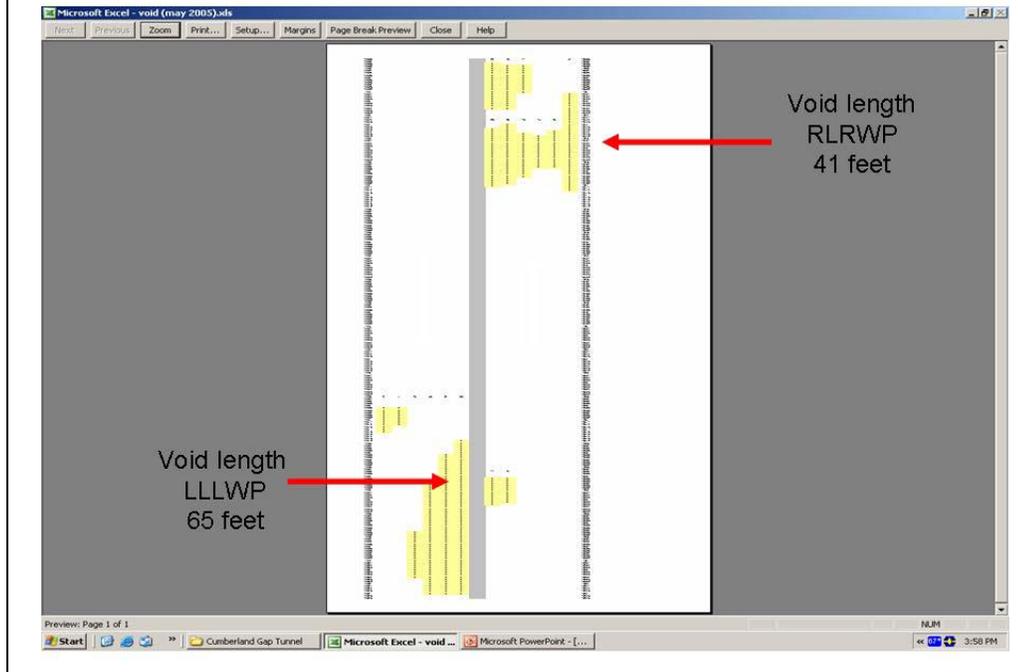
Mapped void area CP 5

Southbound void length CP 5

<u>location</u>	<u>lane</u>	<u>distance from left barrier wall</u>	<u>beg. Station #</u>	<u>end. Station #</u>	<u>Void Length (feet)</u>
lwp	left	4.6	128.49	129.14	65
cwp	left	7	128.55	129.14	59
rwp	left	9	128.66	129.14	48
lwp	right	17.6	128.88	129.07	18
cwp	right	20	128.35	128.42	7
lrwp	right	22.3	128.35	128.45	10

Northbound void length CP 5

<u>location</u>	<u>lane</u>	<u>distance from left barrier wall</u>	<u>beg. Station #</u>	<u>end. Station #</u>	<u>Void Length (feet)</u>
lwp	left	4.6	128.76	128.65	11
lwp	left	4.6	127.40	127.16	25
lwp	left	4.6	127.07	126.88	20
cwp	left	7	128.75	128.65	10
cwp	left	7	127.39	127.14	24
cwp	left	7	127.07	126.89	18
rwp	left	9	127.36	127.18	18
rwp	left	9	127.00	126.89	11
lwp	right	17.6	127.32	127.19	14
cwp	right	20	127.32	127.17	16
rwp	right	22.3	127.42	127.01	41

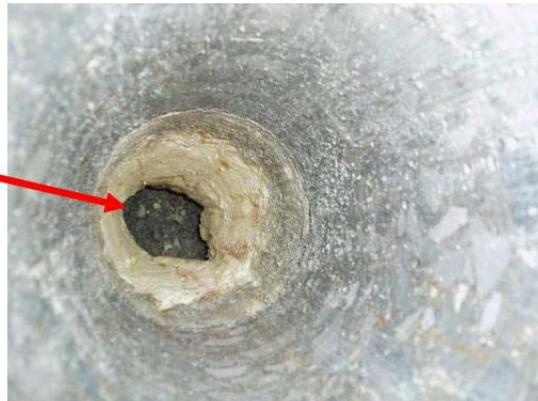
Void depth beneath 10 inch concrete pavement CP 5

Sta. #	Lane	Void depth inch
128+67	L cwp	4 3/4

Void area under URETEK

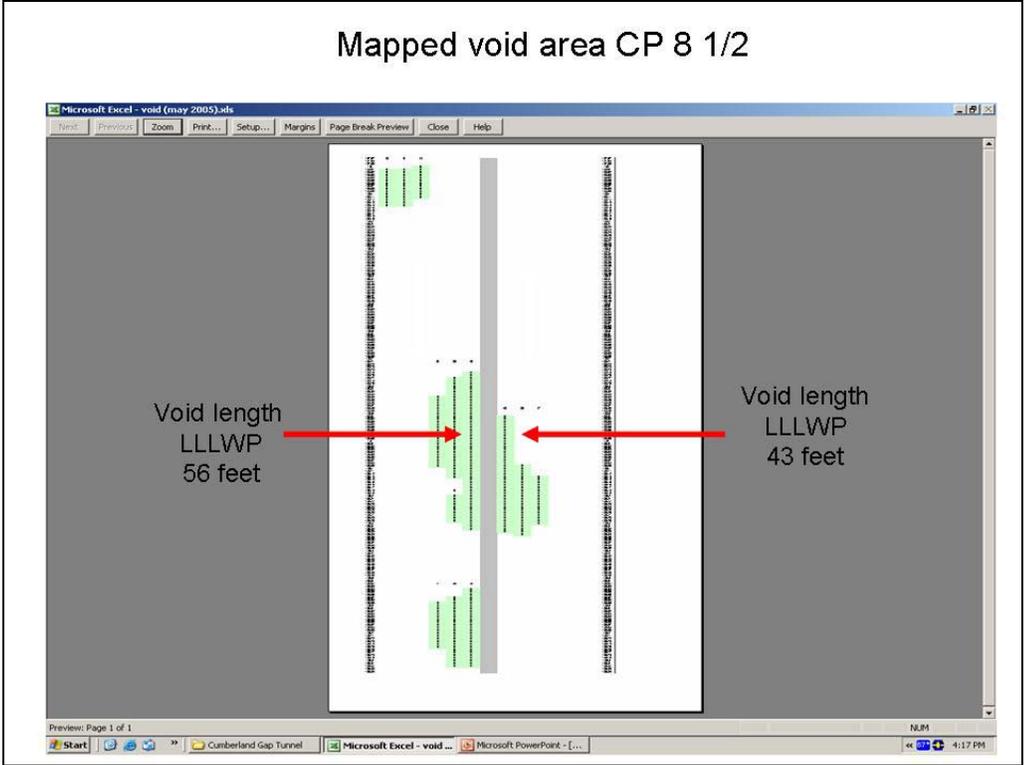
Mapped void area CP 8 1/2

Southbound void length CP 8 1/2

<u>location</u>	<u>lane</u>	<u>distance from left barrier wall</u>	<u>beg. Station #</u>	<u>end. Station #</u>	<u>Void Length (feet)</u>
Lwp	left	4.6	138.75	139.32	56
Lwp	left	4.6	139.54	139.82	28
Cwp	left	7	138.77	139.13	36
Cwp	left	7	139.20	139.29	9
Cwp	left	7	139.57	139.82	26
Rwp	left	9	138.84	139.09	26
Rwp	left	9	139.59	139.75	17
Lwp	right	17.6	138.00	138.11	11
Cwp	right	20	138.01	138.14	14
Rwp	right	22.3	138.01	138.14	13

Northbound void length CP 8 1/2

<u>location</u>	<u>lane</u>	<u>distance from left barrier wall</u>	<u>beg. Station #</u>	<u>end. Station #</u>	<u>Void Length (feet)</u>
lwp	left	4.6	139.33	138.91	43
cwp	left	7	139.34	139.09	25
rwp	left	9	139.30	139.13	17
lwp	right	17.6	0.00	0.00	0
cwp	right	20	0.00	0.00	0
rwp	right	22.3	0.00	0.00	0

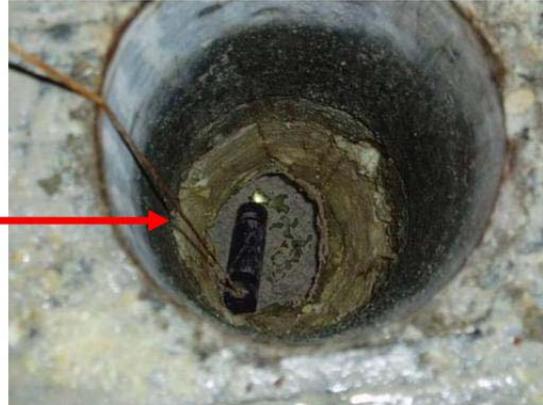
Void depth beneath 10 inch concrete pavement CP 8 1/2

Sta. #	Lane	Void depth inch
138+98	L cwp	21 7/8
139+02	L cwp	29 3/8

URETEK material

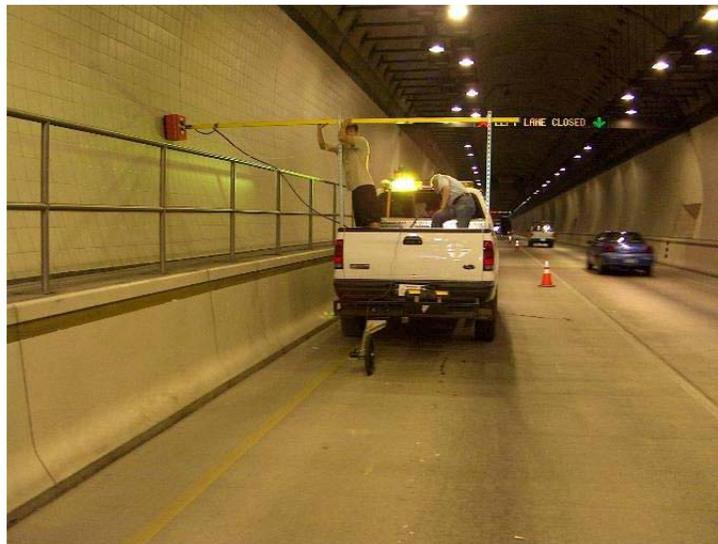
GPR scanning of Walls in concerned areas (July 2005)

- No large void areas were discovered
- Small/medium size voids were less than 12 inches from face of wall
- Believed that these void areas reside inside of the waterproof membrane

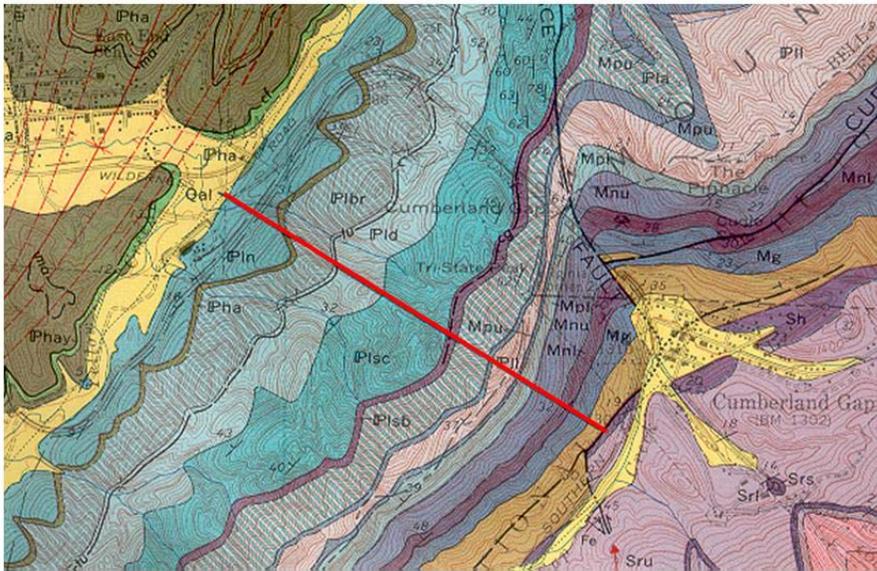
Geology (plan view)

Geology CP 3
Middlesboro formation (sandstone)

- Heavy water in-flow 10-50 g.p.m. (NB tunnel)
- Numerous thin silt/sand seems (both tunnels)
- Weathered face material (both tunnels)
- Water in-flow 10-20 g.p.m. (SB tunnel)
- Clay seems, thin silt seems (SB tunnel)
- Support category IV (both tunnels)

Geology CP 5
Contact between Middlesboro and Dark Ridge

- Water in-flow 3-4 g.p.m. (SB tunnel)
- Mud/sand/water west wall 127+44 (NB tunnel)
- Water in-flow 15-20 g.p.m. (NB tunnel)
- Support category IV (both tunnels)

Geology CP 8 1/2
Pennington formation (sandstone)

- Close to contact between Pennington sandstone and Newman Limestone
- 14 water-seeps, in-flow 1-5 g.p.m. (SB tunnel)
- Poorly cemented sandstone with silt stone (SB tunnel)
- Soft wet mud in areas (SB tunnel)
- 13 water-seeps, in-flow 1-5 g.p.m. (NB tunnel)
- Station 138+73, 2 inch seam of wet sandy mud (NB Tunnel)
